## A Survey of Thatched Buildings in Scotland

Thatch Survey of Scotland  
2014-15

A photographic survey of thatched buildings in Scotland, surveyed between May 2014 and August 2015 by Zoe Herbert (SPAB Scotland Officer), on behalf of the Society for the Protection of Ancient Buildings.

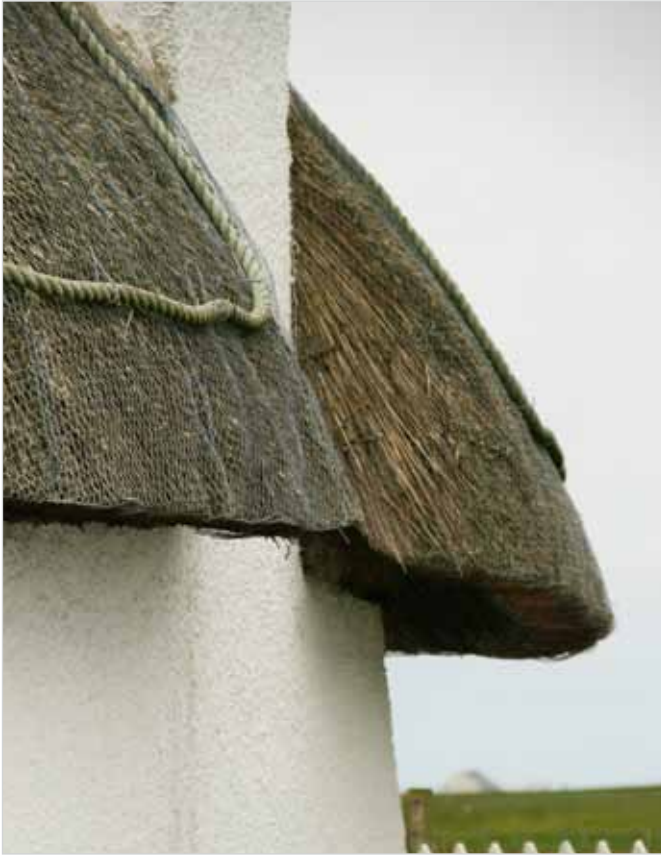
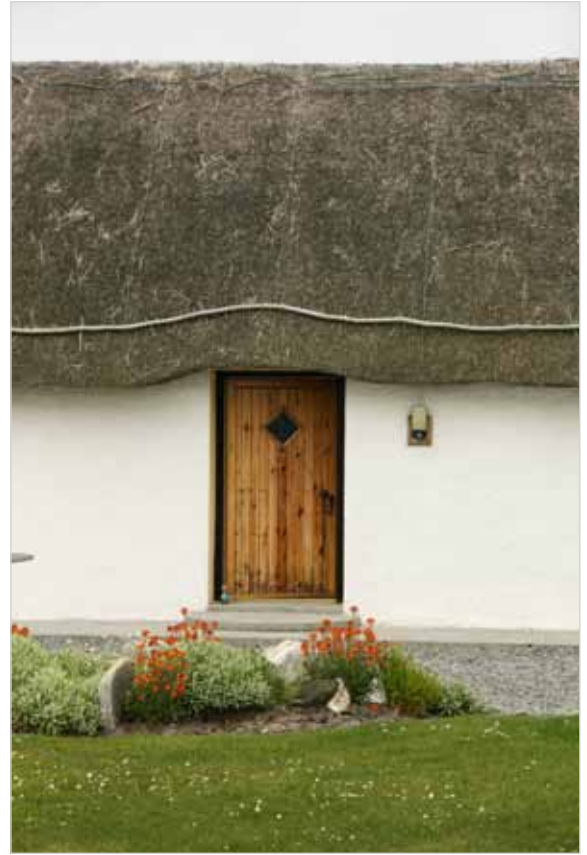
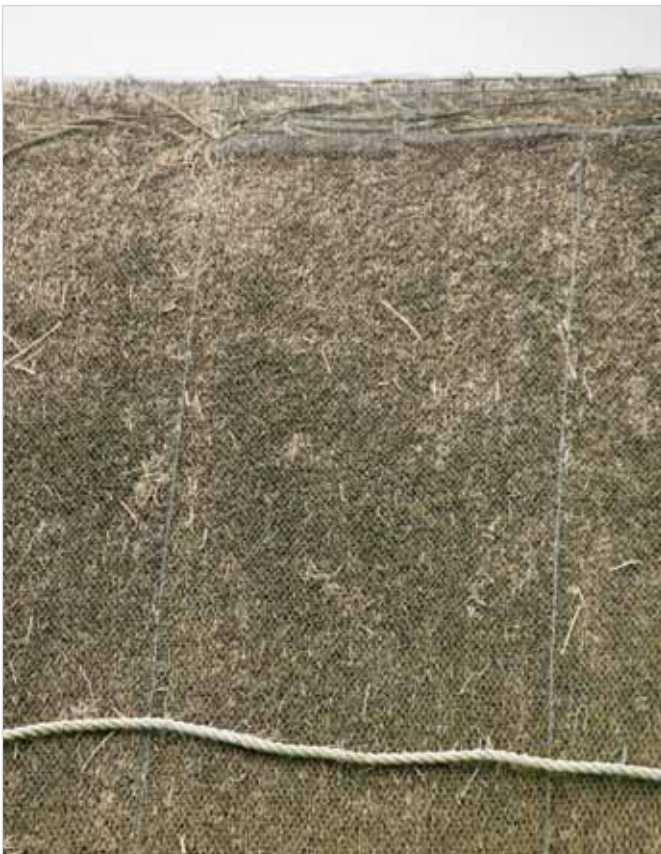
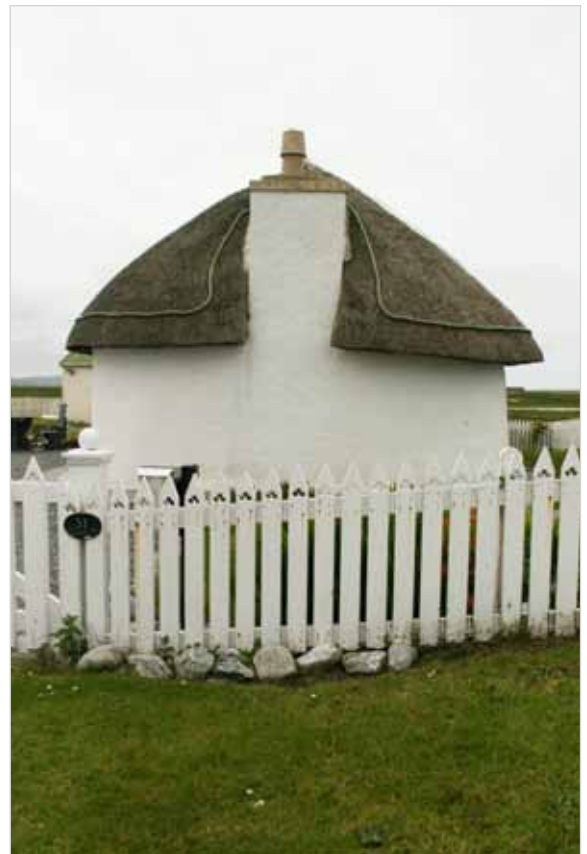
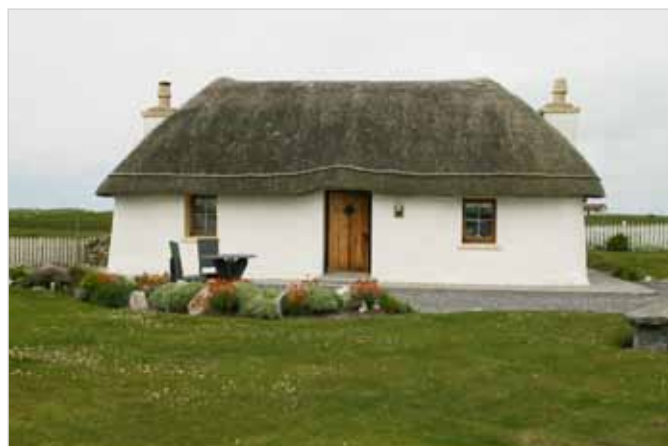
Thatch Type: ..... Reed or Straw  
Ridge Type: ..... Thatched  
Condition: ..... Good

Additional Notes: ..... Probably 19th-century cottage, listed as having a '*muran* thatch roof, secured with ropes and netting; modern brick weights to east, stones used on other elevations' It is unclear what the thatch material currently is – it appears to be thatched in either reed or straw. Due to the condition of the thatch along the ridge, it is also unclear the manner and material in which it is scobed. The entire roof has been netted, and the netting has been secured underneath the eaves. There is a single thick rope secured to the surface of the netting around

a foot above the eaves, around the entire building and the chimney stacks. The rope is primarily used for decorative purposes but also provides a secondary weighting for the netting. The thatch is generally in a good condition; however, there are a few loose sections of thatch underneath the netting.

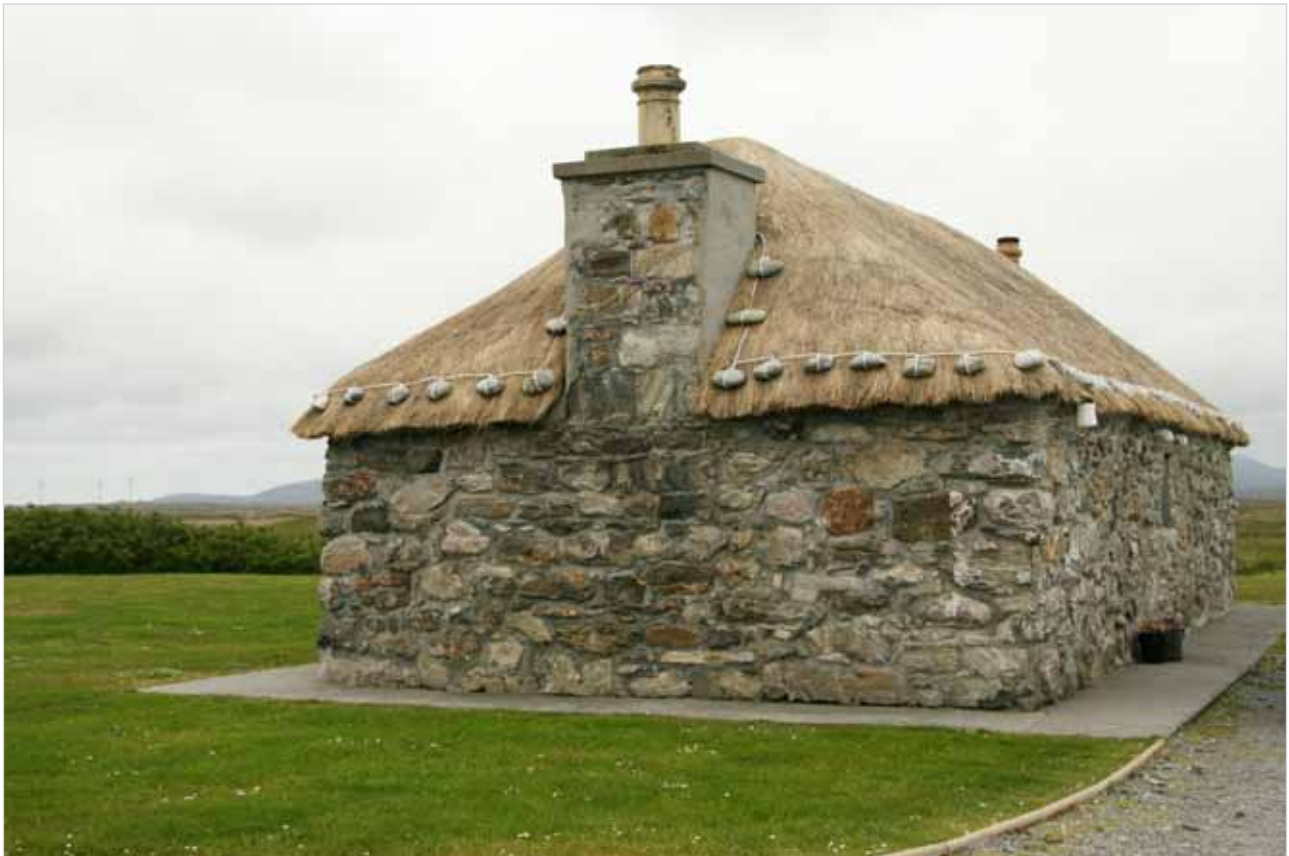
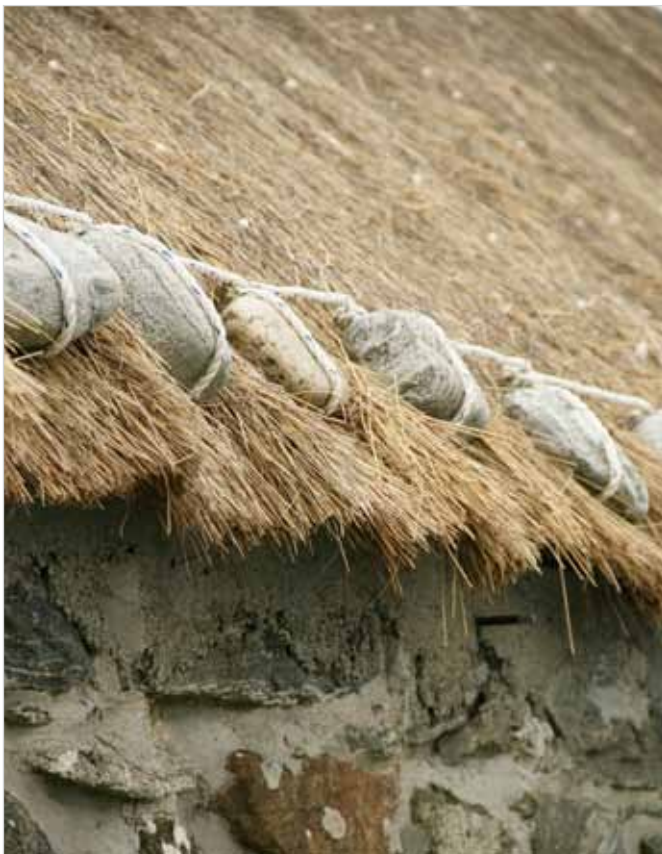
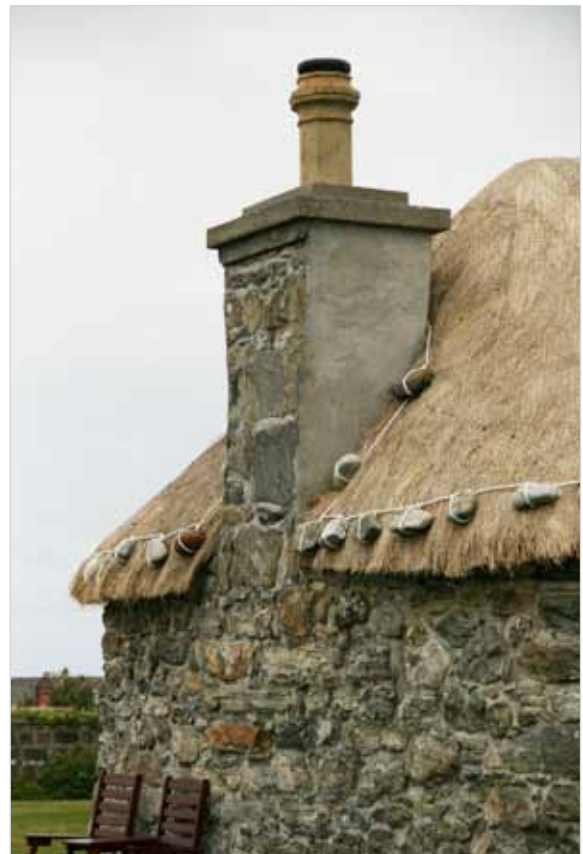
Corrodale Cottage – Western Isles

Thatch Type: ..... Marram  
Ridge Type: ..... Thatched (Marram)  
Condition of Thatch: ..... Good

Additional Notes: ..... Probably 19th-century cottage, listed as having a 'muran thatch roof, overhanging eaves, secured with netting and stone weights'. The cottage has been renovated for use as holiday accommodation but retains a marram-thatched roof with continuous marram ridge. The entire roof has been netted, including across the ridge, which is weighted just above the eaves and around the chimney stacks at either end by stones secured in a continuous string by thin rope passed through the holes in the netting. The listing description for the building notes that a 'shed to north (beside road) [is] also thatched; similar outbuilding to south now derelict'.

The shed to the north that is listed as being thatched is no longer there, though web-based satellite imagery that is now out of date confirms its former existence. The listing description should be updated accordingly.

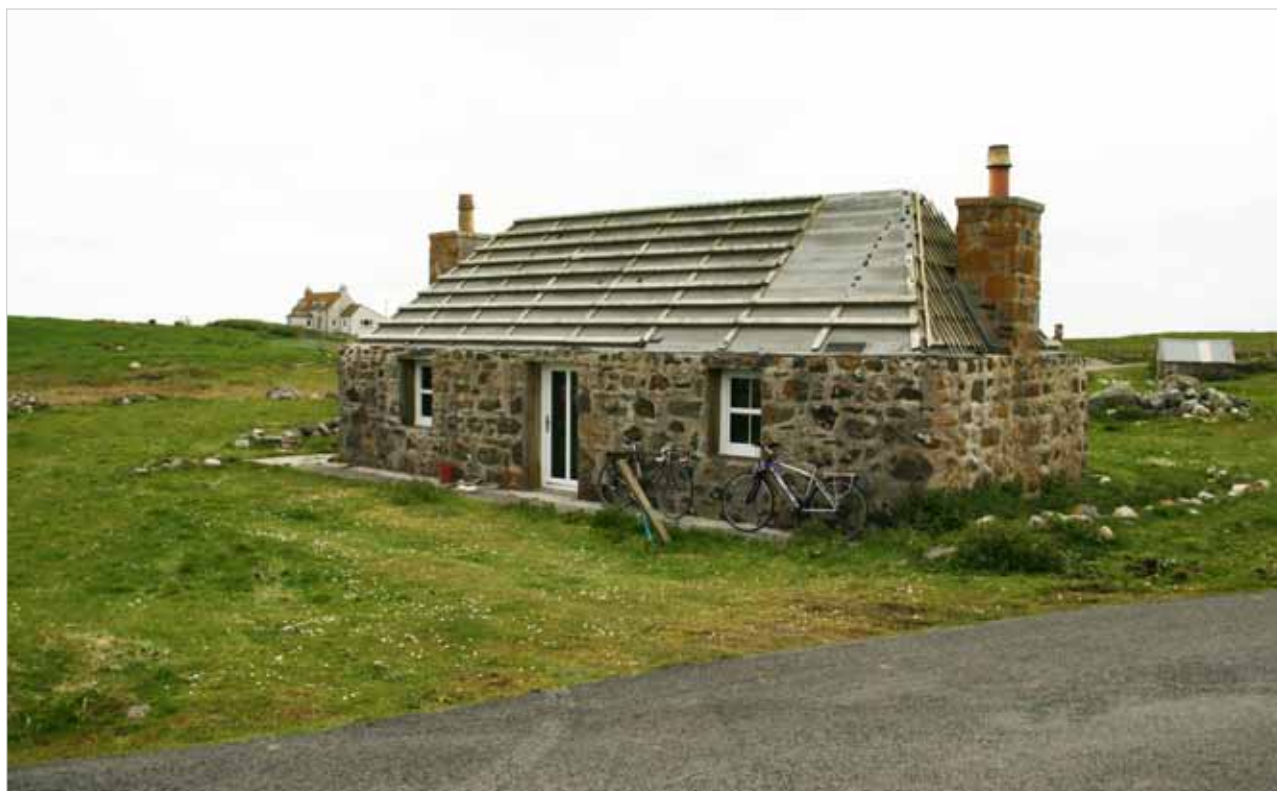
Additional Notes: ..... 19th-century cottage, listed as having a '*muran thatch roof, secured with ropes and stone weights*'. The thatch has since been removed and currently appears to be in the process of having a new roofing material installed. There is no sign of any thatching material remaining anywhere on site. The listing description for the building should be updated accordingly.

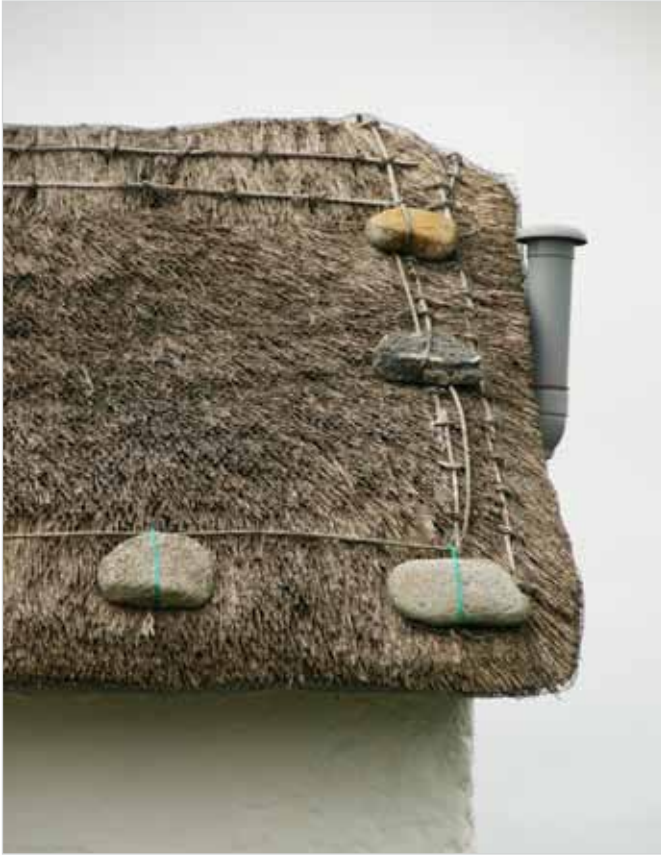
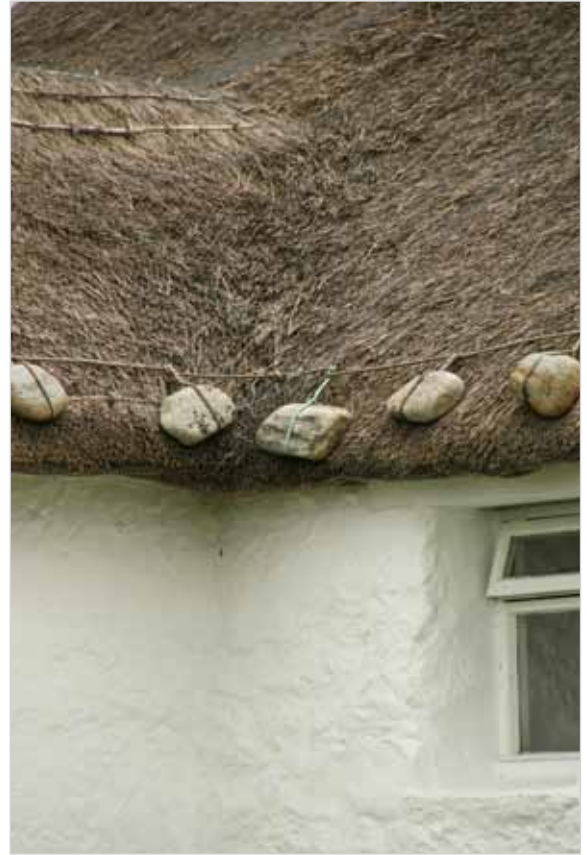
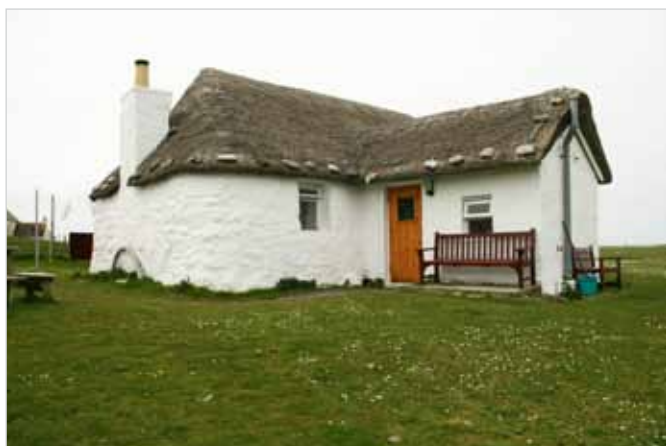
Howmore Hostel – Western Isles

Condition of Thatch: ..... Good

**Additional Notes:** Single-storey cottage with projecting wing to the front (north-east) elevation. According to the Gatliff Hebridean Hostels Trust website ([www.gatliff.org.uk](http://www.gatliff.org.uk)) the hostel at Howmore opened as a hostel in 1966. The roof of both the main cottage and the projecting porch wing are thatched in marram and have a continuous marram ridge. The ridge has been scobed using hazel spars, continued vertically down the skewes on the projecting wing. The entire roof has been netted, and weighted along the eaves and around the chimney stacks at either end of the cottage with stones. The stones have been hung by thin rope in a continuous string,

which has been pegged into the thatch with metal  
pegs above each of the stones.

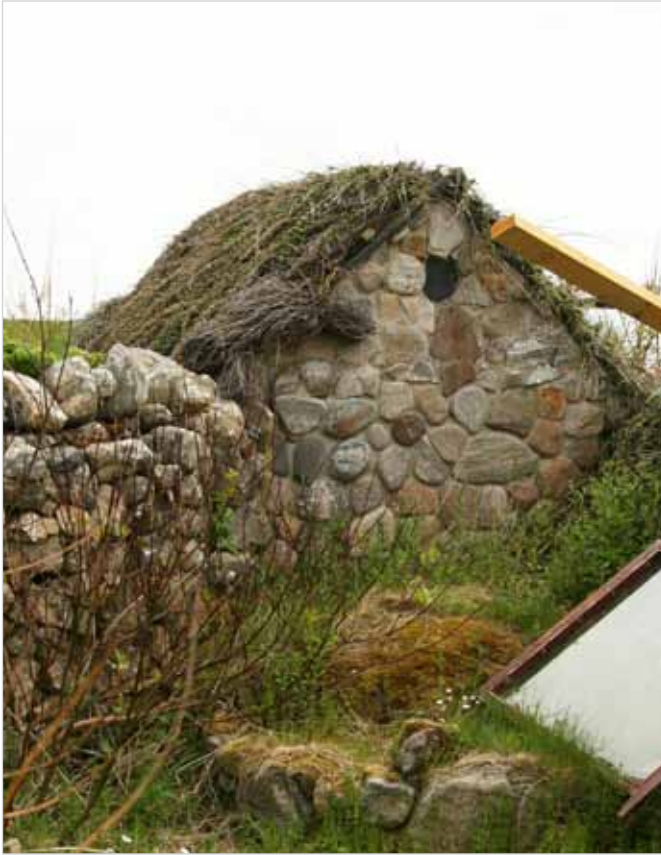
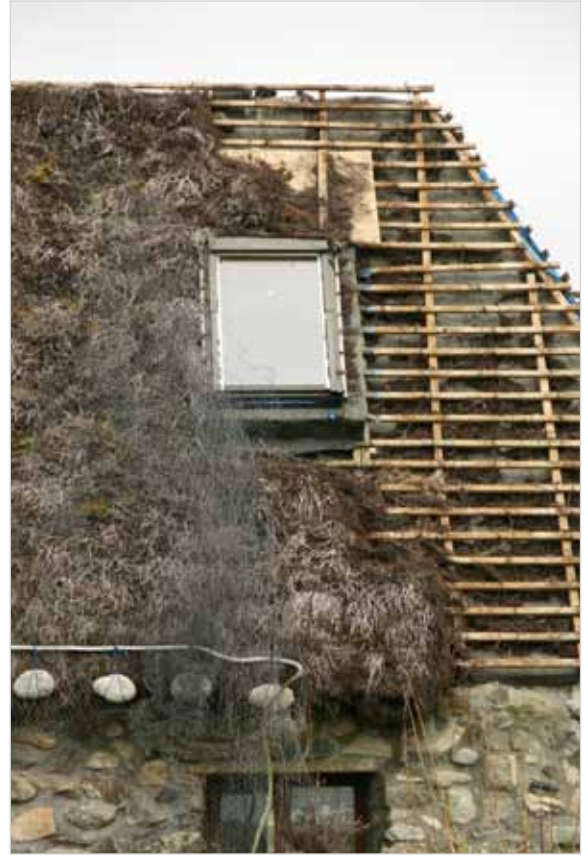
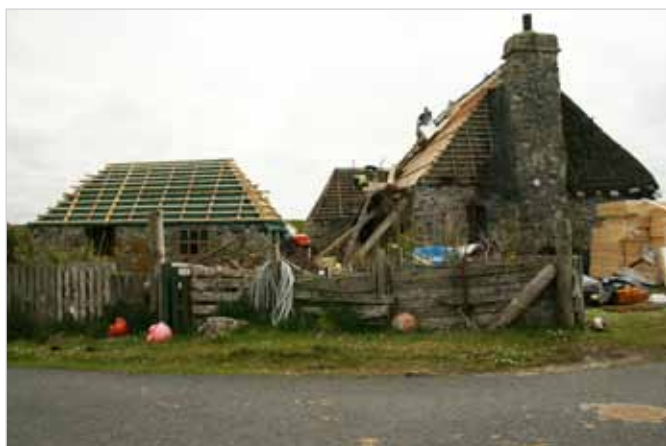
Howmore Thatched House – Western Isles

Condition of Thatch: ..... n/a

**Additional Notes:** ..... Large single-storey with attic cottage and two outbuildings to the east. At the time of visiting, the cottage as well as one of the outbuildings was having the heather thatch removed from the building in preparation for a complete re-thatch. The outbuilding had had the heather completely removed, whilst the cottage retained some of the heather thatch to the west elevation. The ridge had been completely removed, but visible evidence of netting over the heather could be seen, which was weighted down above the eaves and around the chimney stacks at either end with stones secured to a rope that had been strung through the

netting with metal wire. A small outbuilding to the east currently retains its heather roof, though this appears to be in fairly poor condition. The owner plans to re-thatch all roofs in heather.

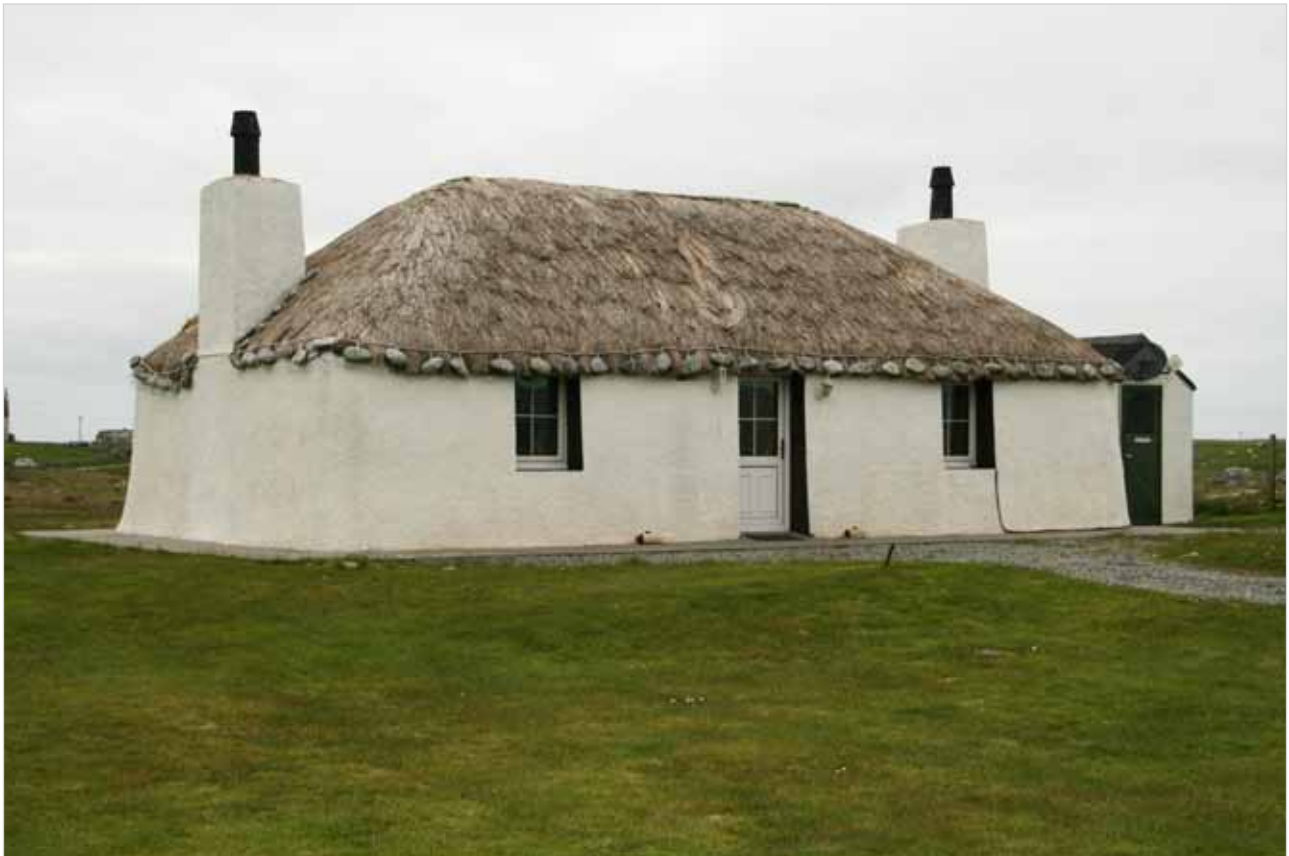
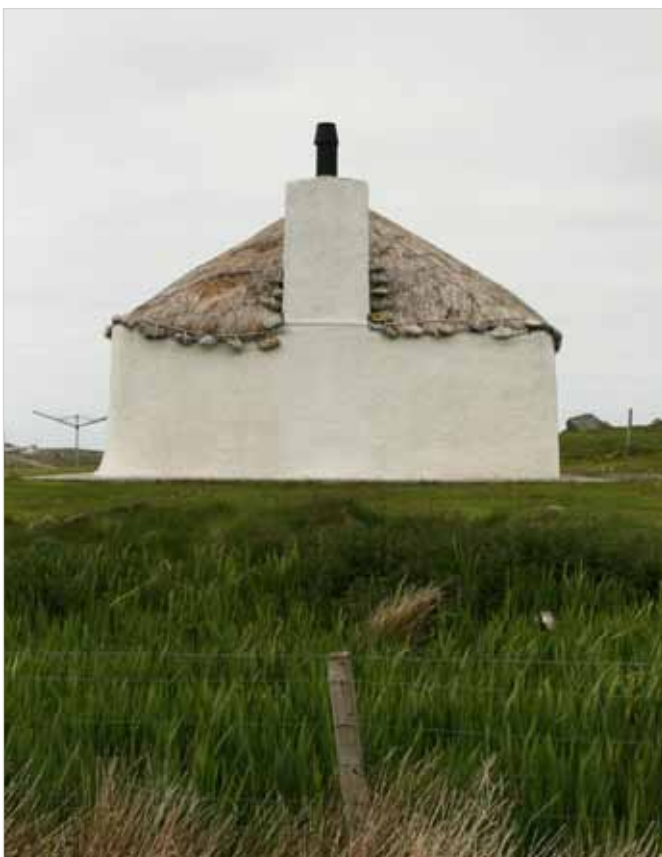
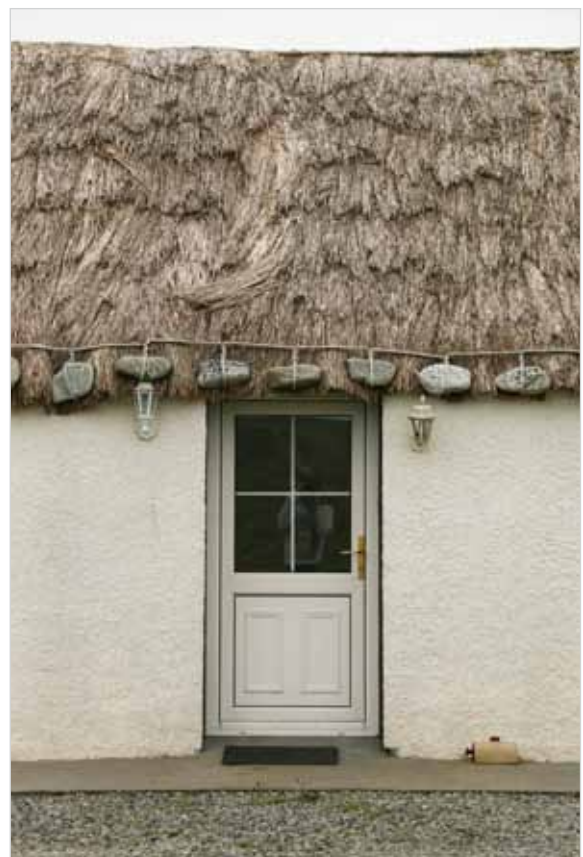
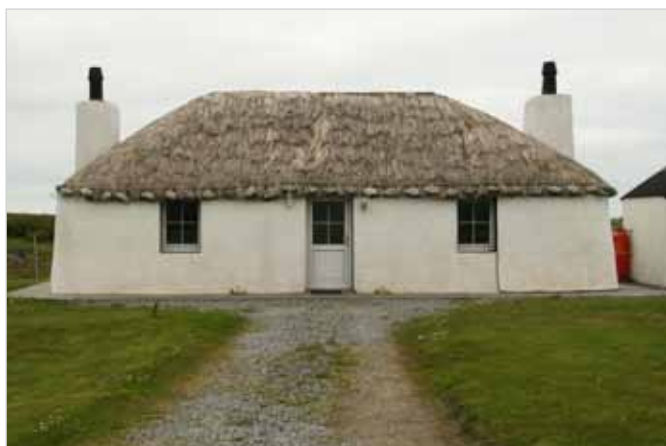
Taigh an t-Saoir – Western Isles

..... Thatched (Marram)

..... Fair

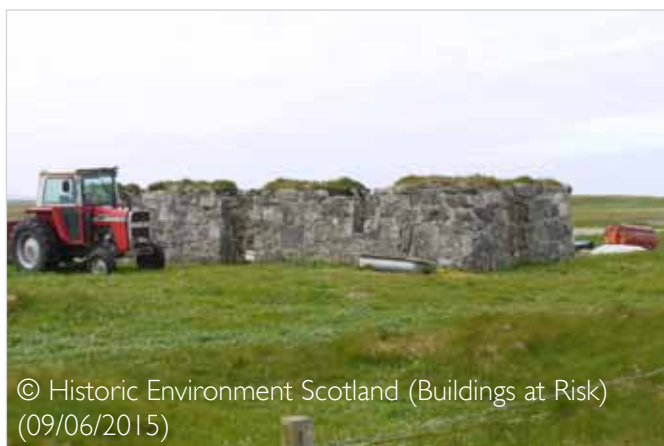
**Additional Notes:** ..... Whilst the name of the building for the listing records it at one location (grid reference NF 74124 21016), the grid reference held by the listing shows another (grid reference NF 74166 21086). The actual building under this listing, confirmed by its Buildings at Risk (BAR) entry, is on the opposite side of the road to the south. The cottage, listed as having a '*muran thatch roof, secured with netting, ropes and stone weights*', is a roofless ruin and has been on the Buildings at Risk Register since 2010 (BAR reference number 4786). The grid reference and listing description should be updated accordingly.

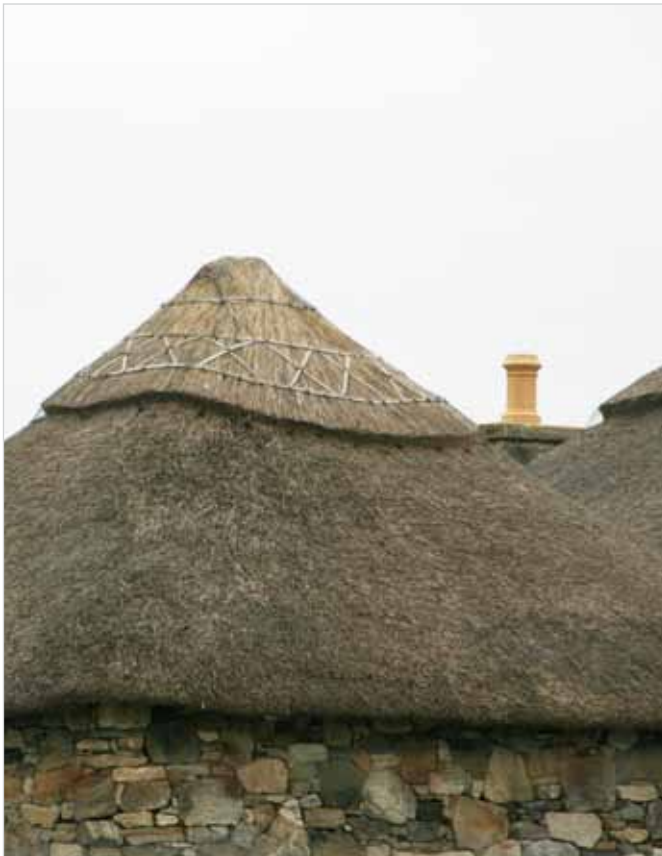
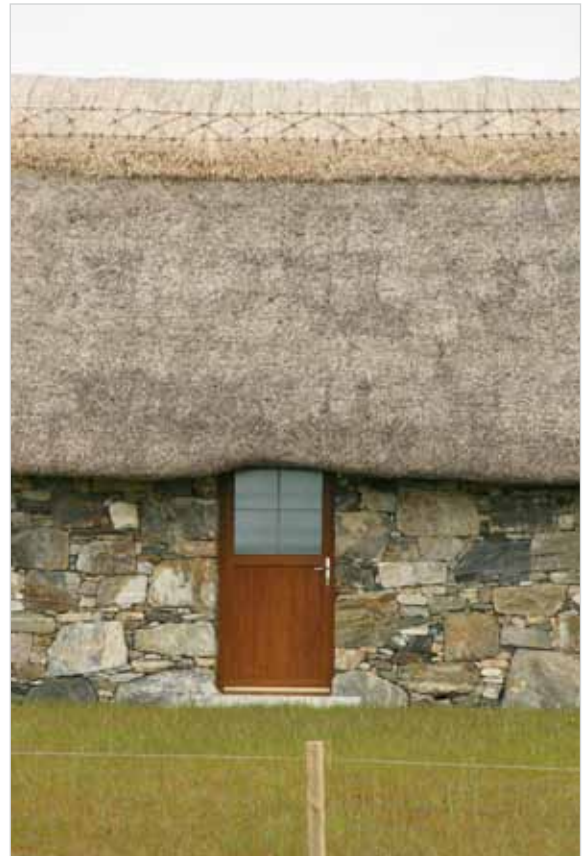
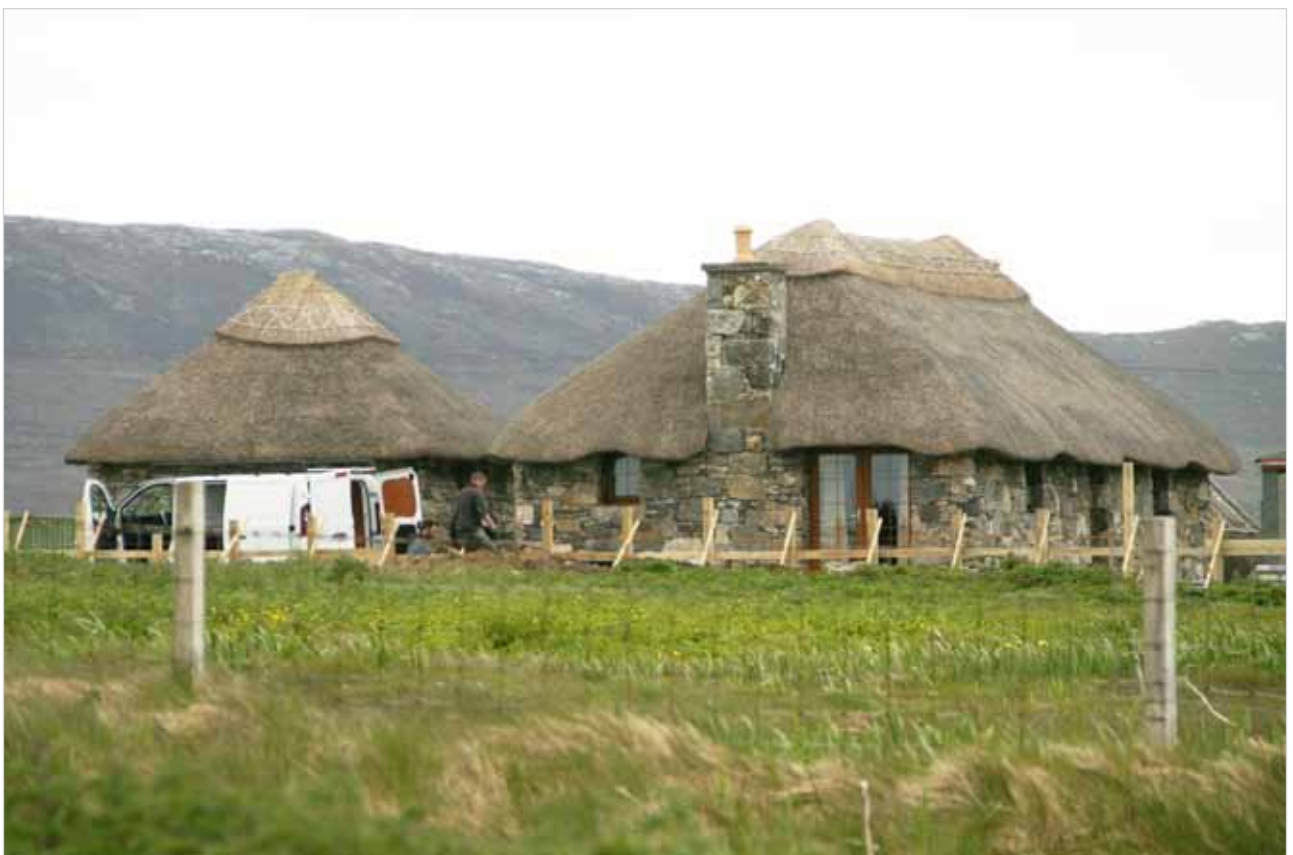
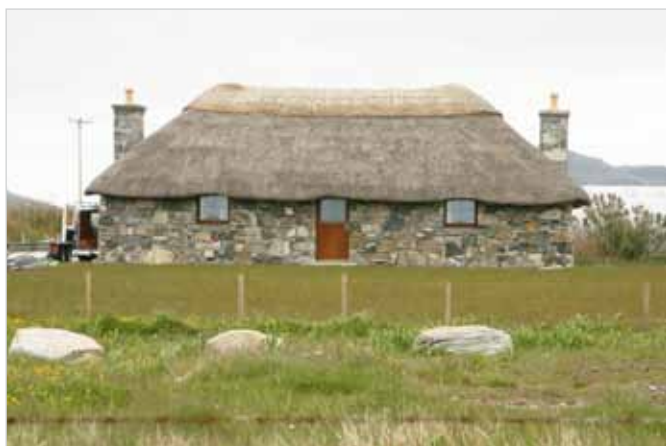
Kilpheder Thatched Cottage – Western Isles

Condition of Thatch: ..... Good

Additional Notes: ..... New build cottage with outbuilding, both with thatched roofs. Neither building appears on the current web-based satellite imagery of unknown date, suggesting that they were constructed fairly recently.

Both the roof of the cottage and the outbuilding appear to be thatched in reed with either straw or marram ridges. The ridge comes down particularly low in comparison to other raised ridges in Scotland, and has been scobed using what appears to be hazel spars. Both roofs have been entirely netted, including across the ridge. The thatch has been sculpted slightly above the window and door openings at the eaves.

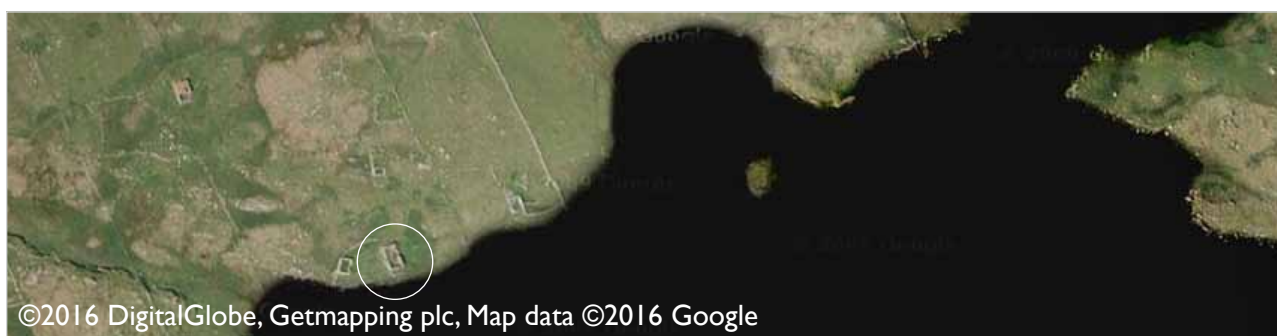
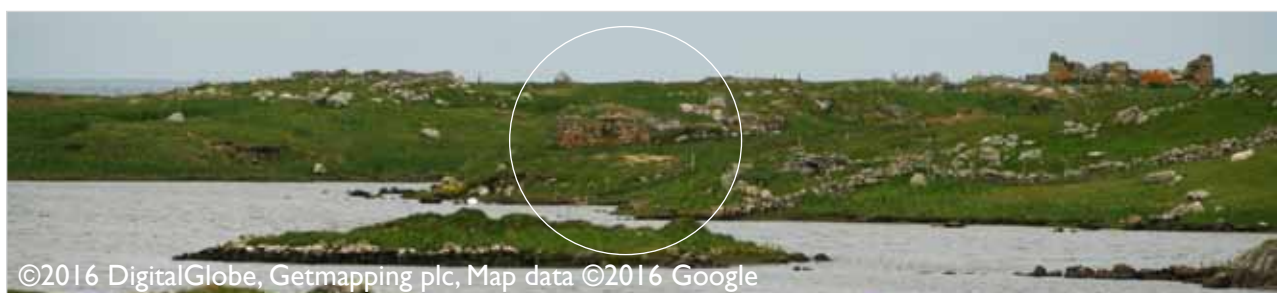
**Additional Notes:** ..... The listed building description reads '*built 1907 or 1908. Skye-type thatched cottage on north shore of Loch an Eilean*' and it is described as having a '*muran thatch roof, secured with ropes, netting and stone weights*'. The site was inaccessible when visiting; however, photographs taken from nearby show a group of ruined cottages in that location, the one believed to be that of this listing clearly seen in a ruinous condition. Web-based satellite imagery confirms that the building identified by the listing is a shell with no roof. The listing description should be updated accordingly.

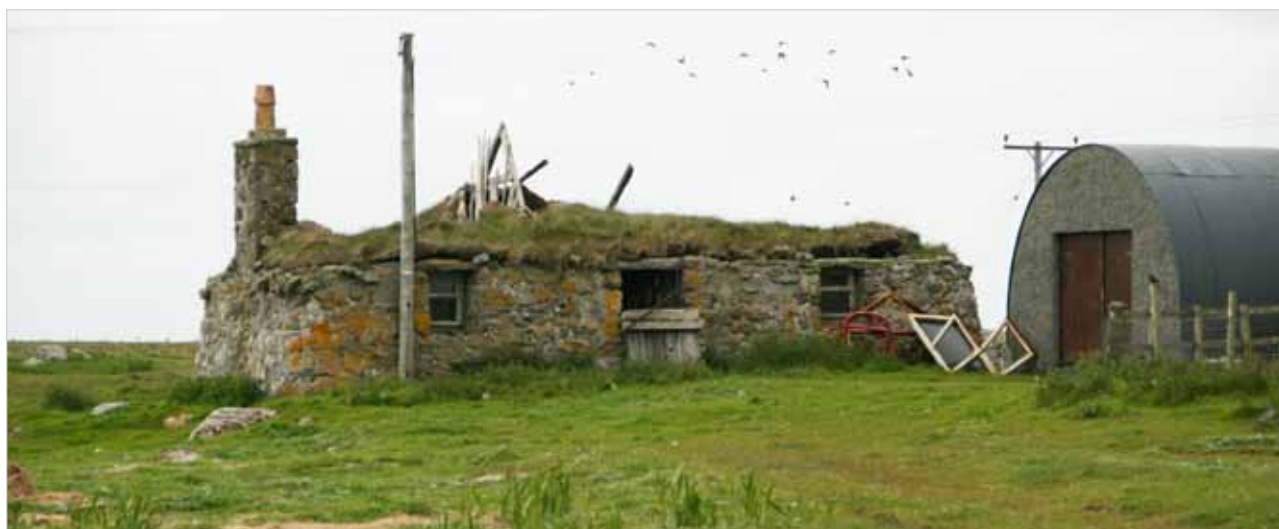
**Additional Notes:** Rebuilt/re-roofed late 19th/early 20th-century cottage, listed as having a '*muran thatch roof, secured with ropes and stone weights*'. The roof of the building has collapsed, though visible evidence of thatching material can be seen still resting upon the wallheads. The building has been on the Buildings at Risk (BAR) Register since 1996 (BAR reference number 1477), at which time it was recorded that the cottage was '*unoccupied and deteriorating rapidly*'. Upon BAR inspection in 2009, it was recorded that the thatched roof had '*collapsed over the north section*' and that the '*rest of the roof has failed and is caving in*'. At some point between 2010, when BAR last visited, and now, the south section of roof has also collapsed. The listing description for the building should be updated accordingly.

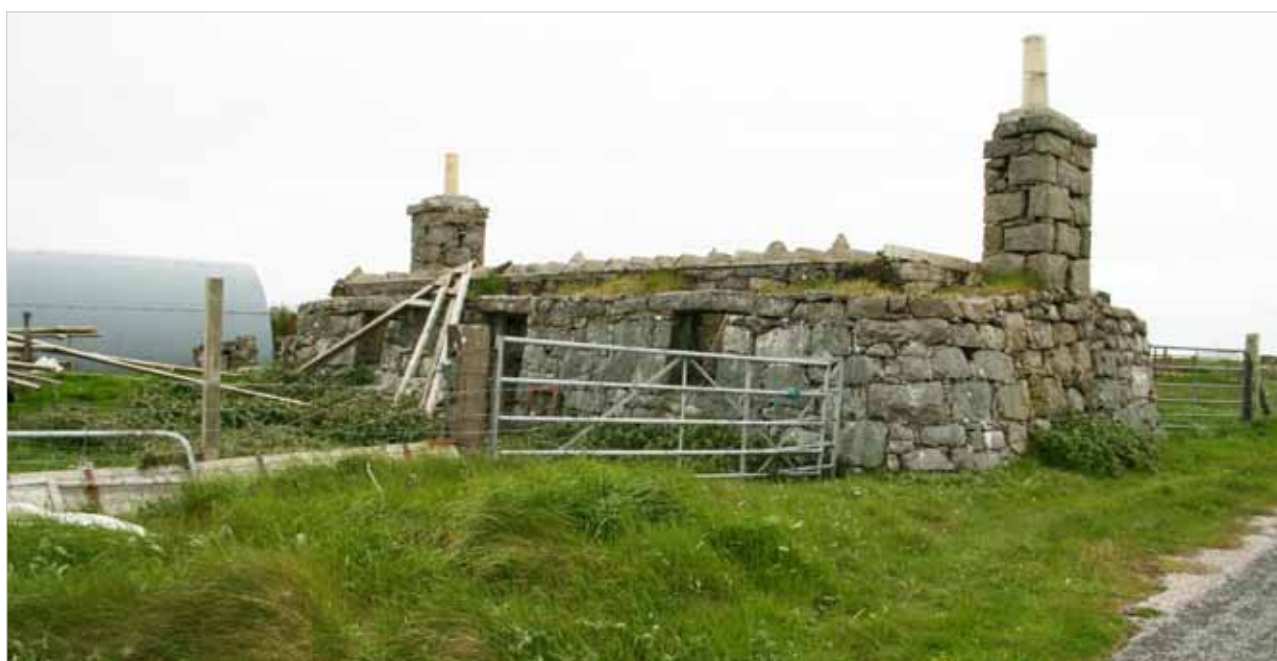
**Additional Notes:** ..... Group listing for a 19th-century cottage and two adjoining outbuildings, with all three structures listed as having '*muran* thatch roofs, secured with ropes and stone weights'. The outbuildings, which are supposed to be located to the south-east of the cottage, appear to no longer be there. The cottage is now a roofless ruin and there are no visible signs of any thatch remaining. The notes of the listed building description state that the buildings were unoccupied in 1983, three years after it was listed in 1980. The listed building description should be updated accordingly.

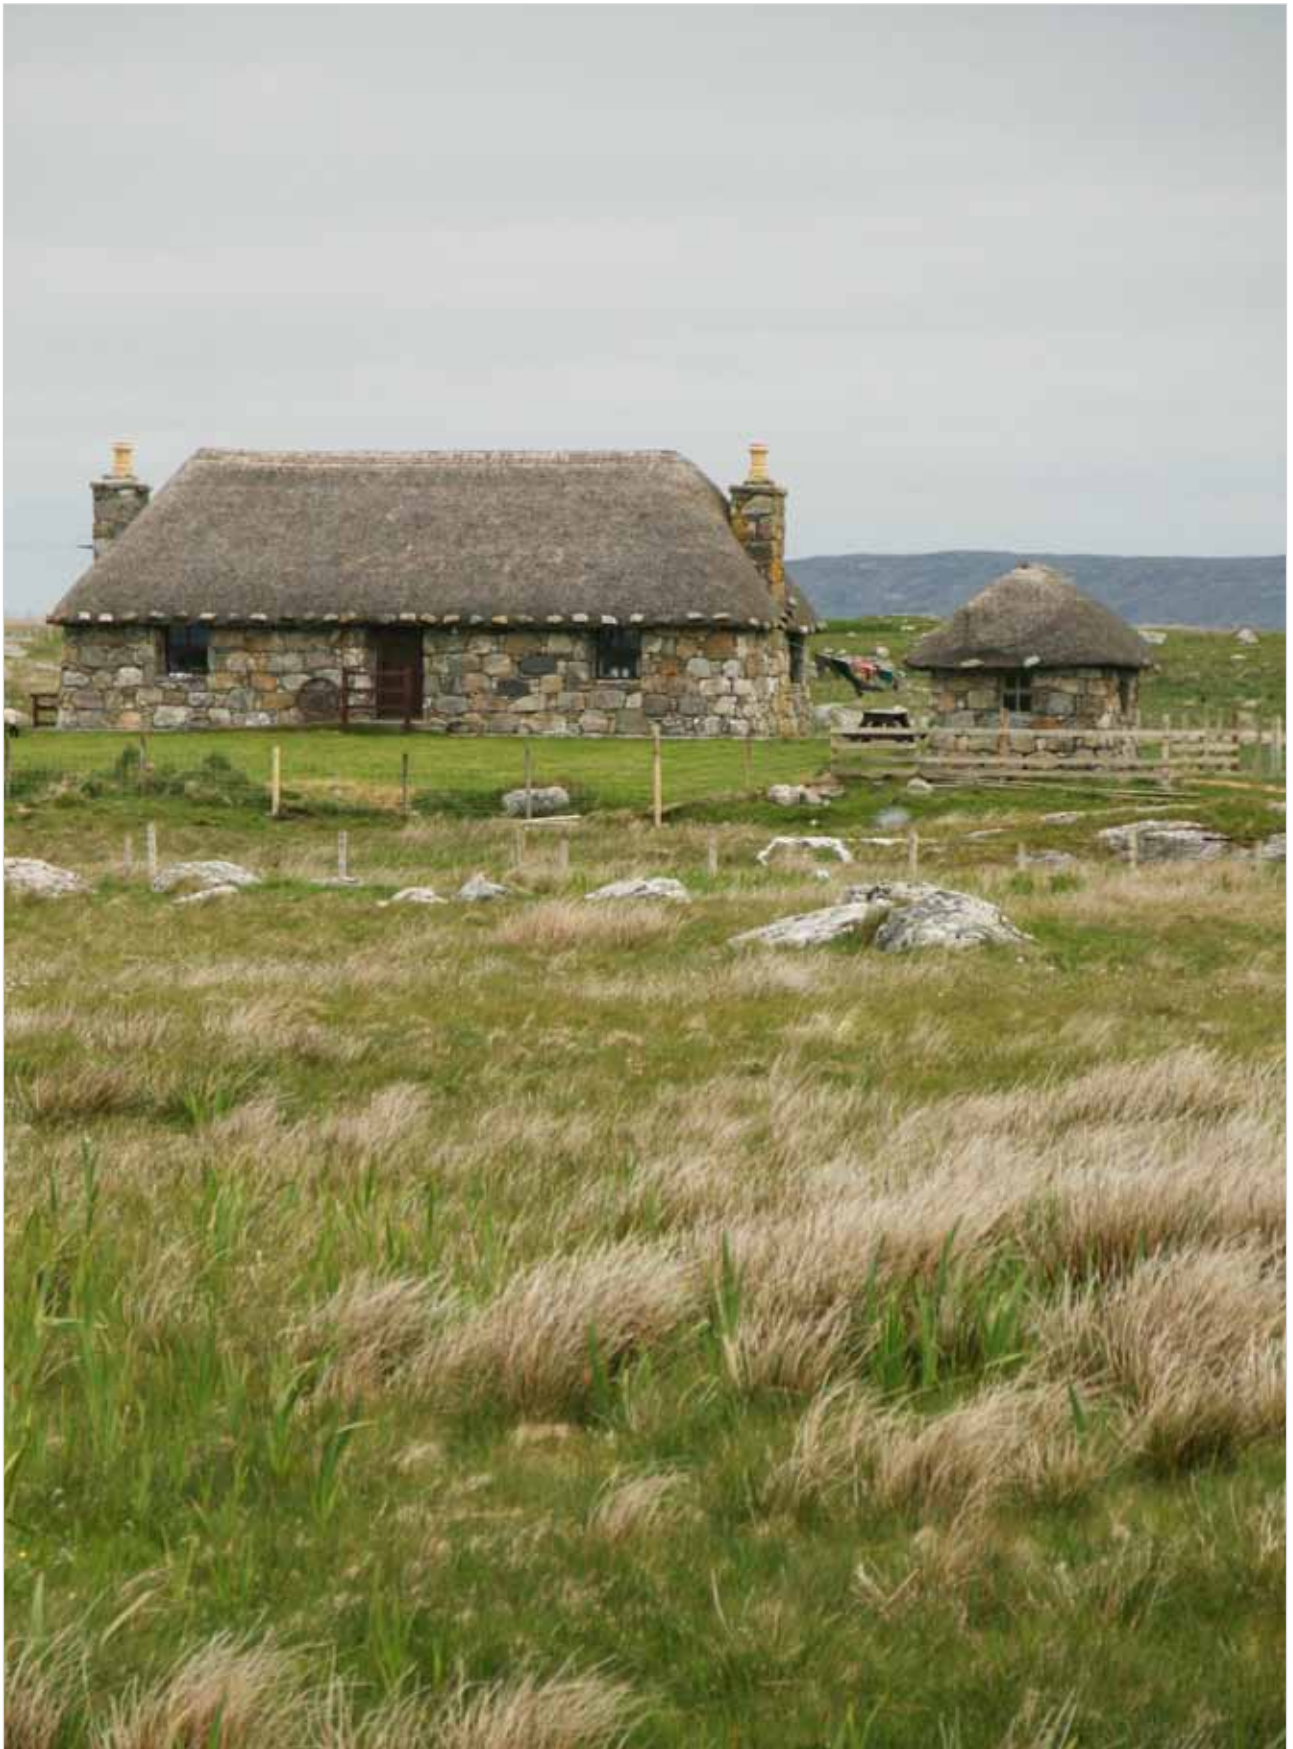
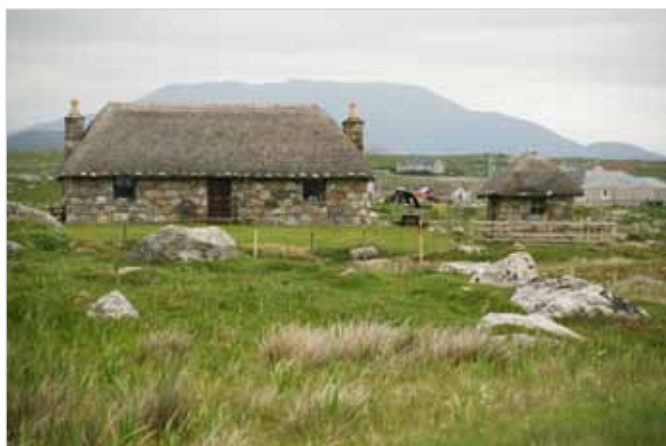
Smiddy Cottage – Western Isles

Condition of Thatch: ..... Good

to the netting with wire. There is a small outbuilding to the south-east, which is thatched in the same manner as

the cottage.
